# Heavy rainfall induced landslides in Bac Kan and Binh Dinh provinces

Do Minh Duc\*

*College of Science, VNU*

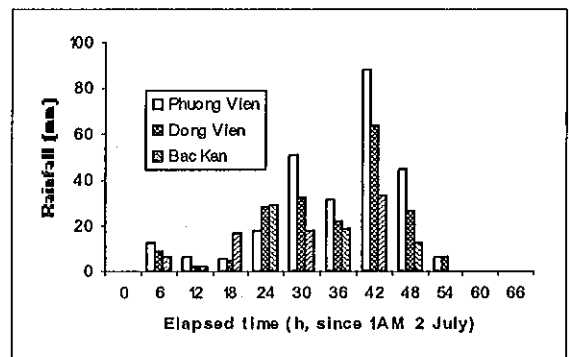
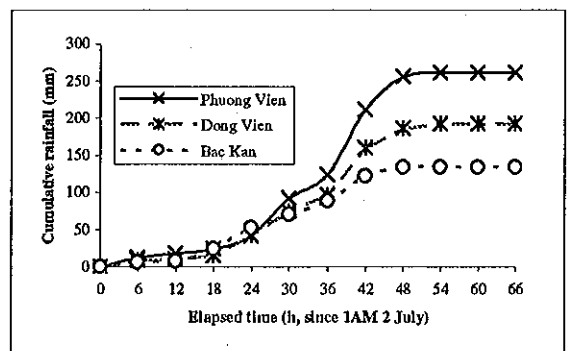
a) Rain fall intensity

b) Cumulative rainfall

Fig. 3. Intensity and accumulation of the rainstorm [3].

mainland. The recorded data every 6h at 3 stations show that the early average rainfall intensity is 2mm/h for the first 18h. It reached to the highest figure of about 15mm/h at the early of 4 July (Fig. 3). The event was then stopped at the end of 4 July. Finally, the rain intensity during storm was 261.1, 191.1 and 133.7mm at Bac Kan, Dong Vien, and Phuong Vien stations, respectively. The rainfall intensity was the highest daily rainfall since 1996. In the storm No. 2 in 2001, there were 11 large landslides with the total volume of about 16,000 m<sup>3</sup>. These ones led to the interrupts in the national highway No. 3 and many other national highways for a long time. The cost of damage was over several billion VND. Along the road No. 3, No. 256 and No. 257 over 30 landslides were recorded to be occurred in this surge storm.

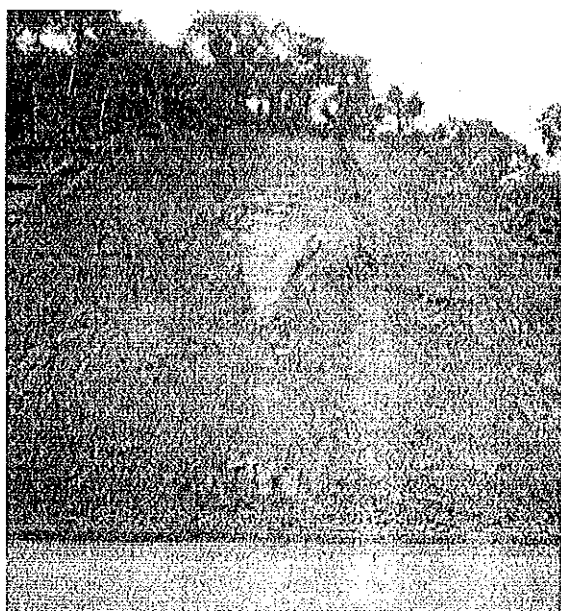
a) Arc slip surface

b) Complex slip surface

Fig. 4. Slip surfaces of landslides.

Landslides in Bac Kan province are often occurred at the slopes of national highways, and only take place in rainy seasons. They can occur either in the weathering crust or in the highly cracked rock masses. The slip surfaces have arc shape in the weathering crust (Fig. 4a) and they coincide with bedding surfaces in high weathered rock masses. The landslides with large volumes often have complex slip surfaces including both arc and flat bedding slip surfaces (Fig. 4b). The volumes range from tens m<sup>3</sup> to

The influence of geological settings is also remarkable beside two reasons of slope angle and heavy rainfall. The bed rocks of schist and clay shale in Bac Kan play the role of an impermeable layer below residual soils (Fig. 4b). When rainy water penetrate into the slopes and reach to that layer it will be accumulated and make a flow down slope. This leads to more rapid increase of PWP in the slopes. In Binh Dinh province this layer is taken place by some intact igneous rocks (Fig.9).

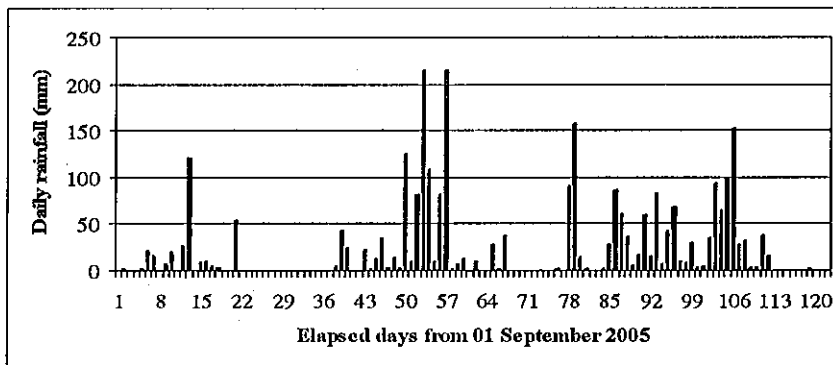
Fig 5. Rainfall from 01 September 2005 to 31 December 2005.

rainfall and this phenomenon the rain data from September to December 2005 is taken into account. The total rainfall in Sept. 2005 was 287.3mm, a normal figure in comparison to other years. In Oct. 2005, the figure was 1016.8mm which is larger than the normalized rainfall with the frequency of 5% (1015mm). Therefore the rainfall in Oct. 2005 was above the figure occurred once every 20 years. The number of rainy days in this month was 20 days continuously. Especially, the rainfall in 3 days (23-25 Oct.) reached to the total of 566.5mm (Fig. 5). However no large landslides occurred during that month. The rainfall in Nov. and Dec. 2005 was 627.6 and 829.0mm, respectively (Fig. 6). The rainfall in Nov. 2005 is also a normal fact. But the one of Dec. 2005 is very remarkable. It is a figure that can only meet once every 50 years. Therefore all of the large landslides occurred in a month with a very high amount of rainfall.

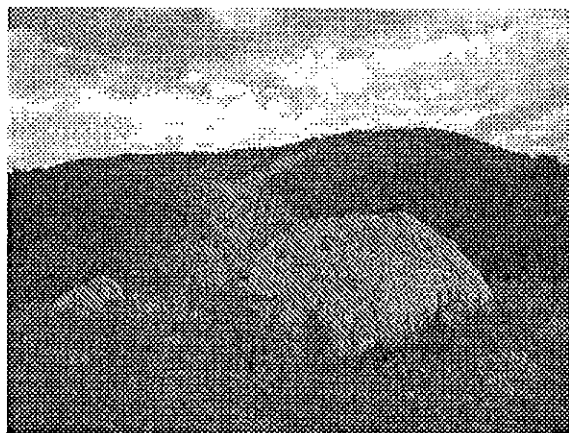
Fig. 7. Landslide in Lang Chom.

The largest landslide took place in Lang Chom with the volume of about 22,000 m<sup>3</sup> (Fig. 7). The landslide occurred with a serious explosion. It might derive from the relieve of compressive pressure in the slope. Other sounds were induced by the movement of soil and rock masses after sliding. The top sliding surface situates in the weathering crust however most of sliding surface is the interface of intact igneous rocks. Residual soils are weathered from rocks of Deo Ca complex with the thickness of 4-6m. The slope is 65 high, and slope angle of 27° – 32°. Lots of rock masses of about 10m<sup>3</sup> were transported down slope along the distance of hundreds meters. The sliding materials then destroyed a local road segment and filled up the Lau stream near the slope causing an increase of 2-3m of the stream water level. Fortunately, there was no debris flow due this phenomenon.

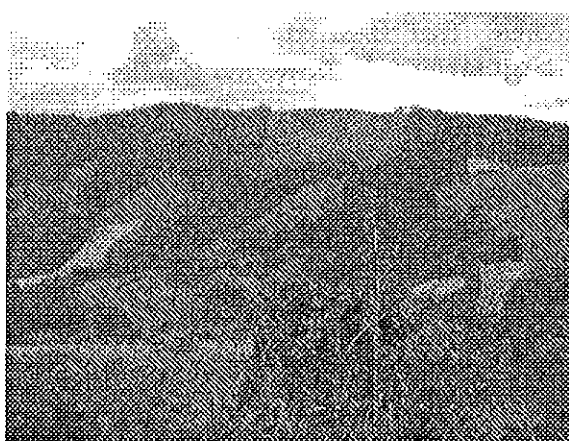
Fig. 8. Landslides in Ka Bung.

At the same time in Ka Bung (the opposite site of the mountain) there was a series of large landslides (Fig. 8). The thickness of residual soils is 6-9m. The slope angle is 27° – 32°. The average volume of these landslides is 10,500m<sup>3</sup>. The landslides took place far from resident area and did not cause any fatality.
